Woodbourne HOA
Littleton, CO

Report #: 44158-0
Beginning: January 1, 2022
Expires: December 31, 2022

RESERVE STUDY
"Full"

March 16, 2022

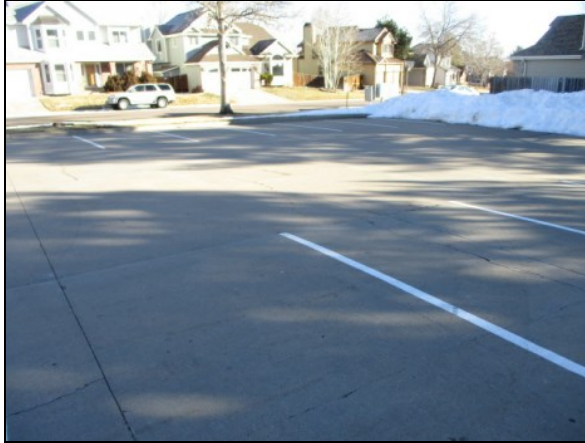
Remaining Life:

2 years

Best Case: \$ 5,100

Worst Case: \$ 7,600

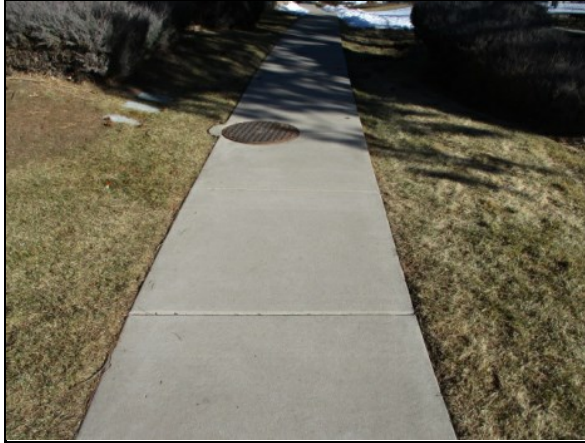
Useful Life:
5 years

Remaining Life:
2 years

Best Case: \$ 1,200

Worst Case: \$ 1,800

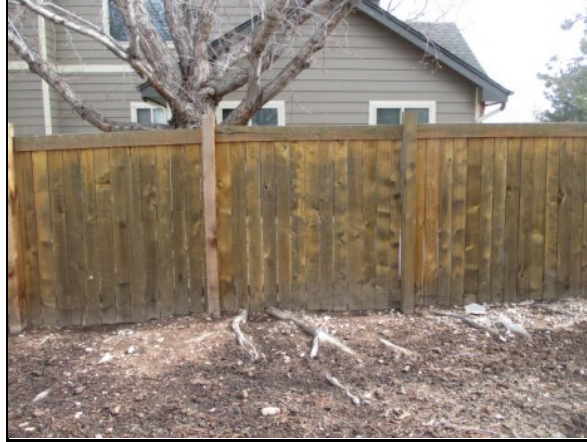
Useful Life:
5 years

Remaining Life:
2 years

Best Case: \$ 21,800

Worst Case: \$ 32,800

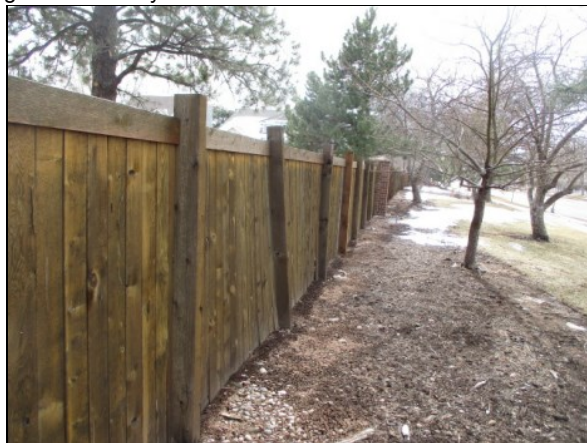
Useful Life:
25 years

Remaining Life:
7 years

Best Case: \$ 140,000

Worst Case: \$ 175,500

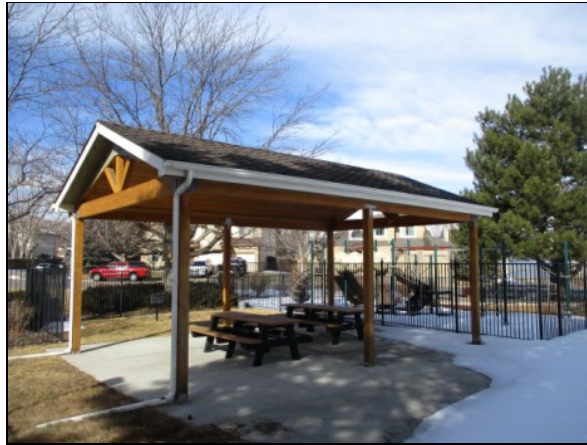
Useful Life:
10 years

Remaining Life:
3 years

Best Case: \$ 580

Worst Case: \$ 960

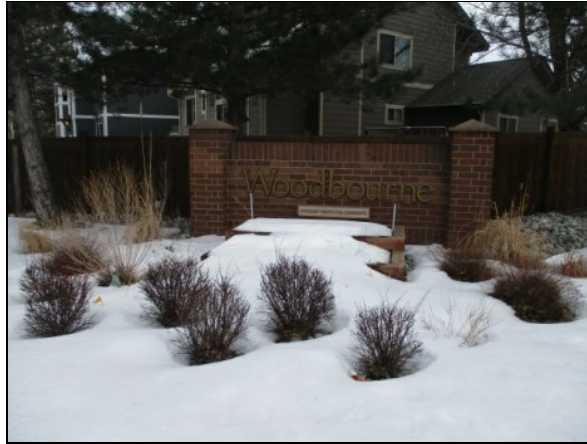
Useful Life:
30 years

Remaining Life:
8 years

Best Case: \$ 5,000

Worst Case: \$ 7,000

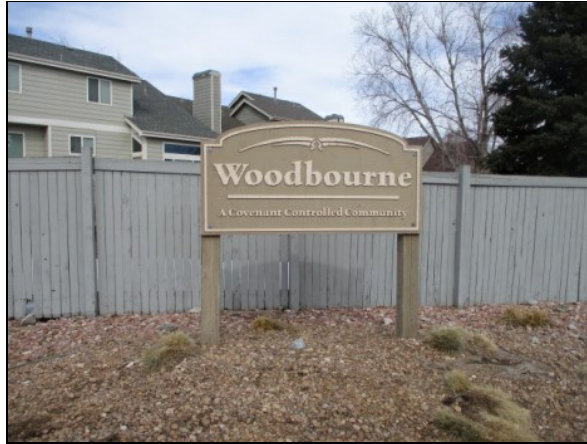
Useful Life:
20 years

Remaining Life:
0 years

Best Case: \$ 4,000

Worst Case: \$ 8,000

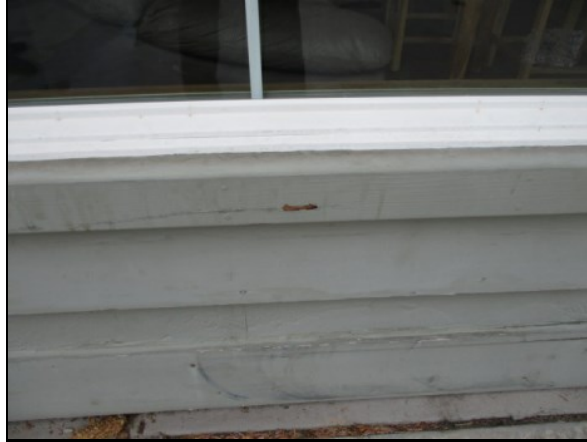
Useful Life:
7 years

Remaining Life:
0 years

Best Case: \$ 600

Worst Case: \$ 1,000

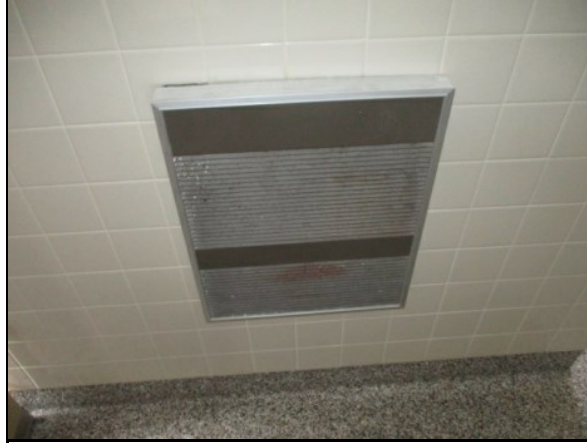
Useful Life:
20 years

Remaining Life:
1 years

Best Case: \$ 4,500

Worst Case: \$ 7,500

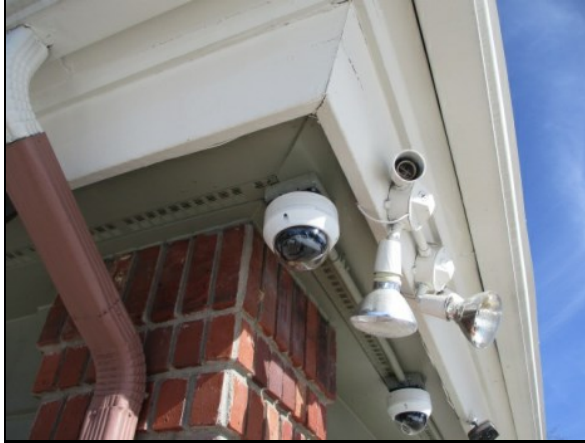
Useful Life:
10 years

Remaining Life:
0 years

Best Case: \$ 4,000

Worst Case: \$ 5,600

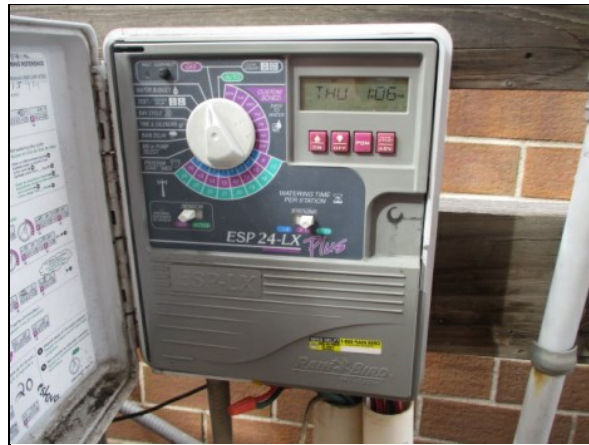
Useful Life:
8 years

Remaining Life:
0 years

Best Case: \$ 2,100

Worst Case: \$ 4,500

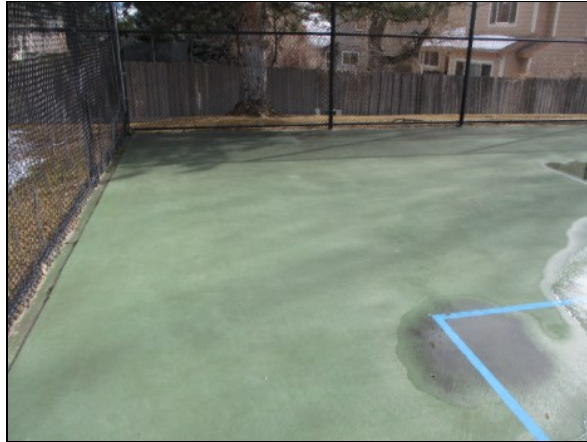
Useful Life:
7 years

Remaining Life:
0 years

Best Case: \$ 14,000

Worst Case: \$ 20,000

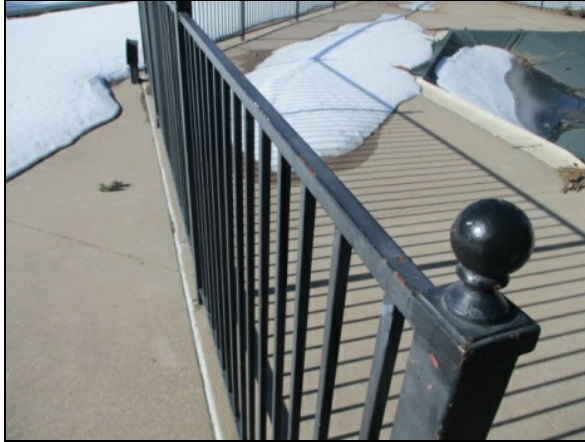
Useful Life:
5 years

Remaining Life:
0 years

Best Case: \$ 3,800

Worst Case: \$ 5,000

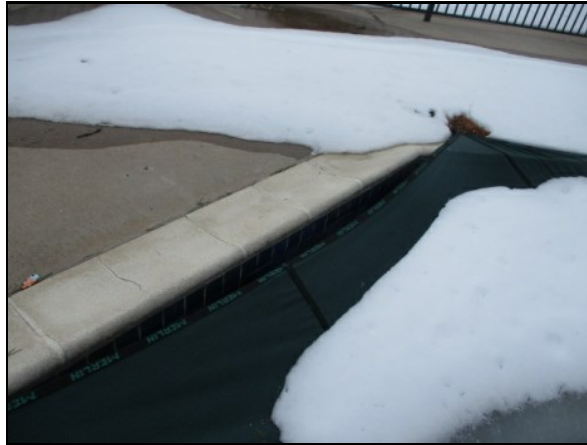
Useful Life:
24 years

Remaining Life:
0 years

Best Case: \$ 19,300

Worst Case: \$ 22,800

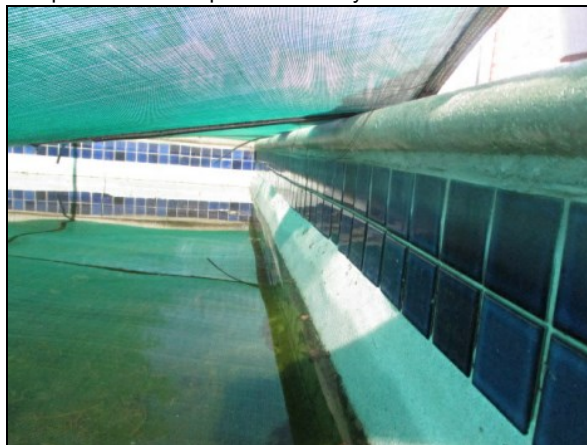
Useful Life:
24 years

Remaining Life:
0 years

Best Case: \$ 12,000

Worst Case: \$ 18,000

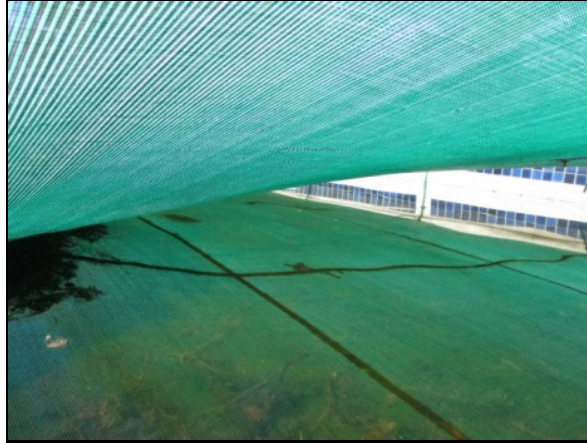
Useful Life:
12 years

Remaining Life:
0 years

Best Case: \$ 77,400

Worst Case: \$ 109,600

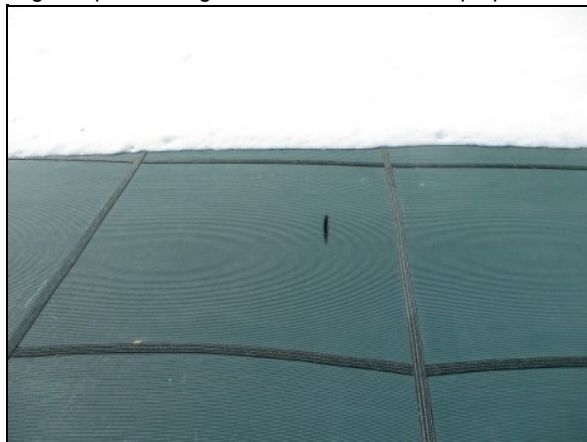
Useful Life:
8 years

Remaining Life:
0 years

Best Case: \$ 14,800

Worst Case: \$ 19,200

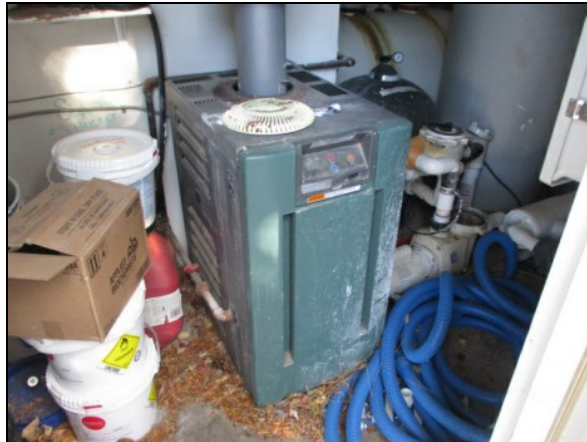
Useful Life:
12 years

Remaining Life:
0 years

Best Case: \$ 3,500

Worst Case: \$ 4,000
