Woodbourne HOA
Littleton, CO

Report #: 44158-0
Beginning: January 1, 2022
Expires: December 31, 2022

RESERVE STUDY
"Full"

March 16, 2022

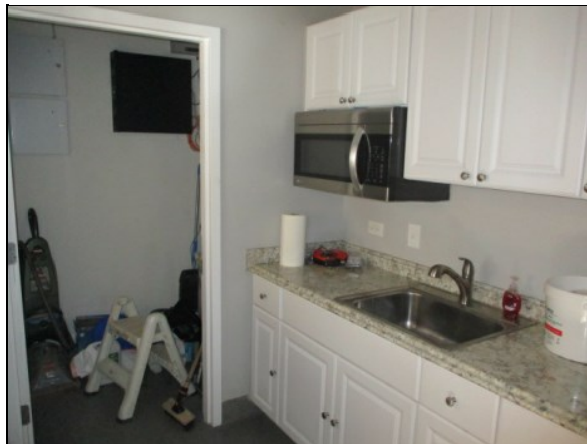
Comp #: 27320 Kitchen Appliances - Replace

Comments: Includes (1) Refrigerator and (1) Microwave. Individual appliances were not tested during inspection and are assumed to be in functional operating condition unless otherwise noted. Useful life can vary greatly depending on level of use quality care and maintenance etc. Funding recommendation shown here is for replacing with comparable quality commercial-grade appliances.

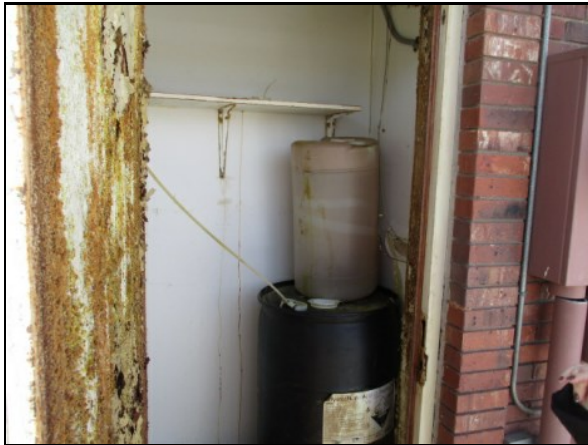
Comp #: 23410 Pool Chemical Room - Repair/Replace

Comments: Reported that room will be "guttled" in 2022 cleaned, painted, and restored. Significant damage due to chemicals. May consult with a professional as to the best way to store these items. In general costs related to this component are expected to be included in the client's Operating budget. No recommendation for Reserve funding at this time. However any repair and maintenance or other related expenditures should be tracked and this component should be re-evaluated during future Reserve Study updates based on most recent information and data available at that time. If deemed appropriate for Reserve funding component can be included in the funding plan at that time.

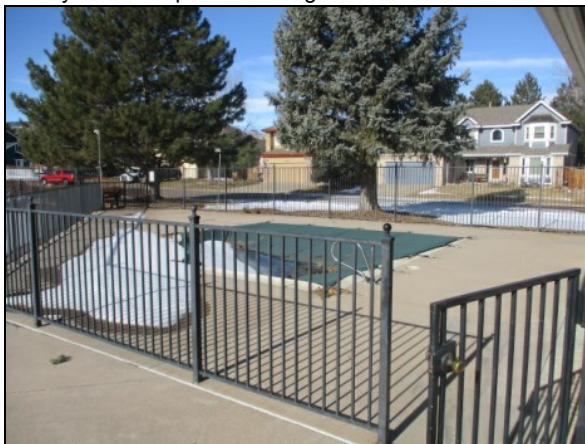
Comp #: 28030 Pool Fence - Replace

Comments: Metal railing determined to be in fair condition typically exhibits some minor to moderate amounts of surface wear and other signs of age which may include corrosion loose or unstable pieces/sections or hardware and/or overgrowth by surrounding vegetation. Overall appears to be in serviceable but declining condition. In our experience metal railing will typically eventually break down due to a combination of sun and weather exposure which is sometimes exacerbated by other factors such as irrigation overspray abuse and lack of preventive maintenance. For some types of fencing complete replacement is advisable over recoating or refinishing due to relatively short lifespan of coatings and consideration of total life-cycle cost.

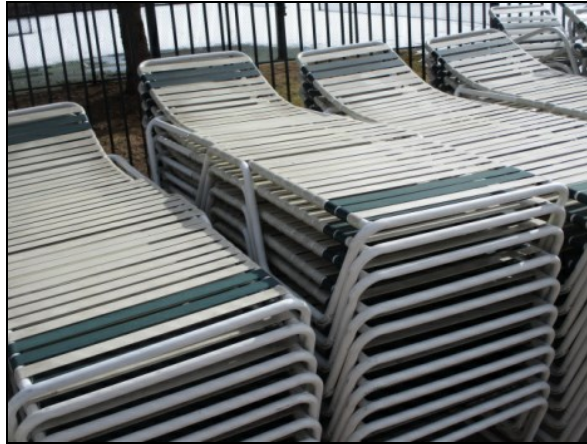
Comp #: 28040 Pool Deck Furniture - Replace - 10%

Comments: Includes (56) Chairs, (40) Chaise Lounges, (8) Tables, (6) Umbrellas, and (7) Drink Tables. The furniture appeared in fair condition. No damage fading or outdated appearances of the furniture was observed. We recommend regular inspections and repair or replacement of any damaged pieces promptly to ensure safety. Protected storage of furniture when not in use can help to extend useful life. Best practice is to replace all pieces together in order to maintain consistent style and quality in the pool/recreation area. Costs can vary greatly based on type of pieces selected for replacement. Funding recommendation shown here is based on replacement with comparable number and quality of pieces.

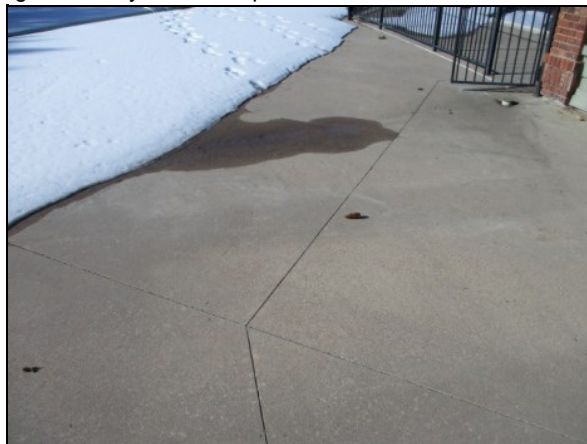
Comp #: 28060 Deck - Repair - 10%

Comments: Decking was observed to be in fair condition. The concrete surfaces exhibited minor hairline cracking and with some shrinkage and settlement cracks observed which can result in water entry to the base which can ultimately lead to trip hazards. Pool decks may be exposed to harsh chemicals that can leave stains if not addressed properly. Periodic pressure-washing and re-coating will restore the appearance and prolong the need for major restoration or replacement of the deck surface. Take note of any places where water is ponding which may result in slip-and-fall hazards if not corrected.
